## RESIDENTIAL INSPECTION

376 Spreading Oak Ln  
Rancho Cordova, CA 95670

11/03/2025

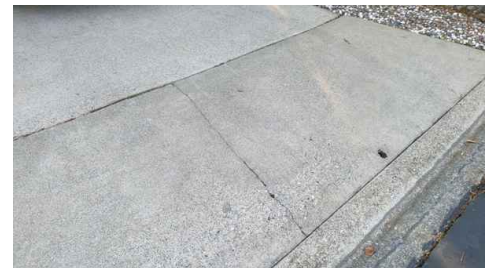
**DRIVEWAY CRACKING**

Cracking observed, which may indicate movement in the soil. Recommend monitor and/or have concrete contractor repair/seal.

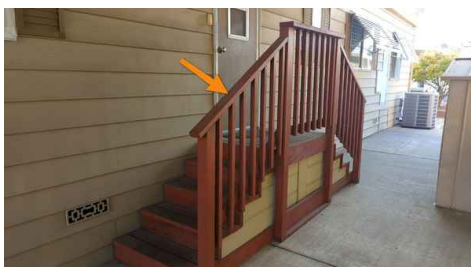
**LOOSE RAILING**

Handrail is loose. This could pose a safety hazard. Recommend a qualified contractor evaluate and fasten.

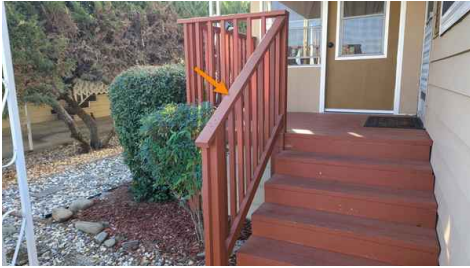
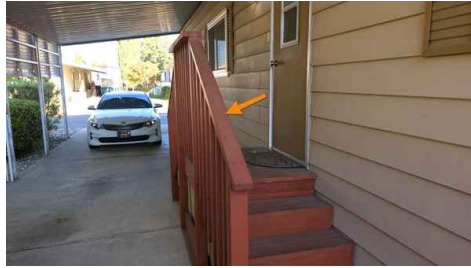
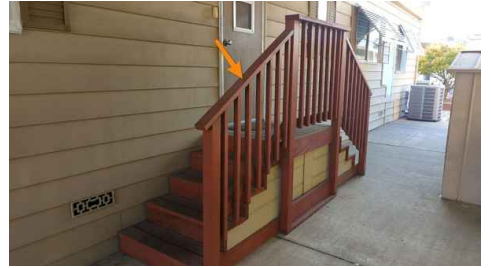
### 2.3.2 Exterior Steps & Railings

#### IMPROVE HANDRAIL FOR EASY GRASPING

At the time of installation the handrail may have met accepted standards however it would benefit from improvement/upgrading to current standards for a graspable handrail. Potential fall hazard. Safety upgrade recommended.

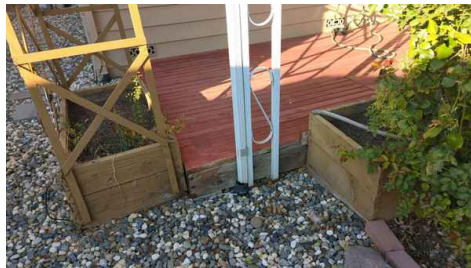
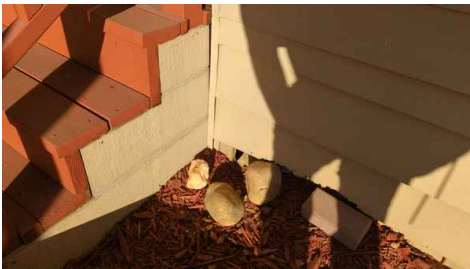
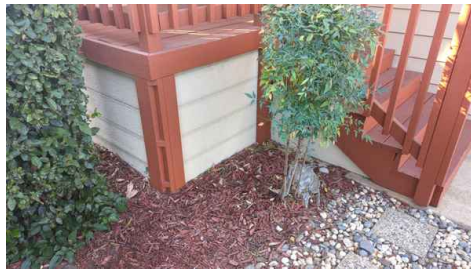
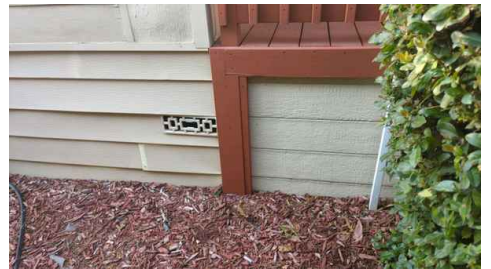
### 2.5.1 Decks & Balconies

#### DECK - EARTH TO WOOD CONTACT

LEFT SIDE DECKING, PORCH, AND SUN ROOM

Earth to wood contact was noted. This allows for a direct path for wood destroying insects and should be corrected.

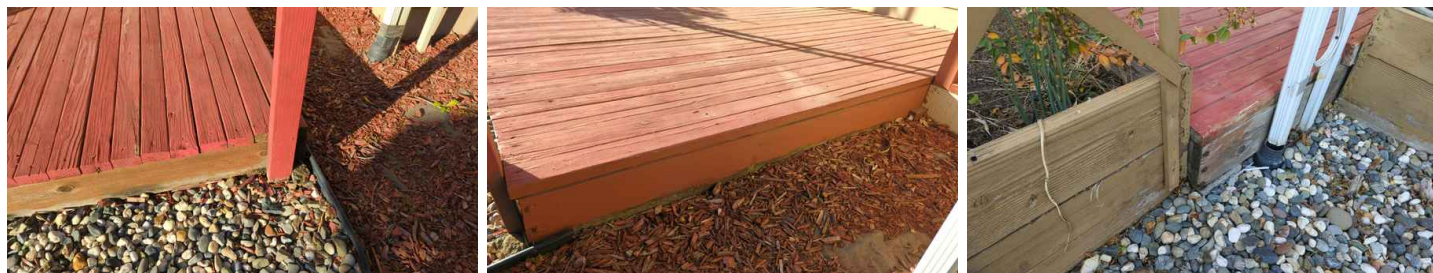
One or more deck components are showing signs of deterioration. Have a licensed contractor make further evaluations and repairs. A WDO (Wood Destroying Organism) inspection is recommended for further evaluation.

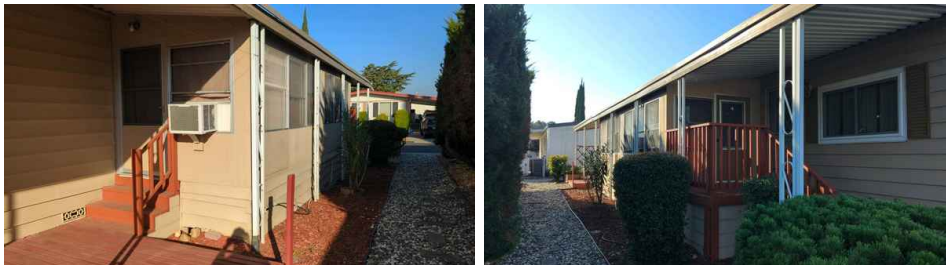
Addition(s) appear to have been made to this property. Therefore, you should request documentation that would include permits and any warranties or guarantees that might be applicable. Our inspection does not endorse or tacitly approve any work completed without a permit, and latent defects could exist. It is in your best interest to ask for full disclosure for all newly completed work, additions, or installations from the seller or you or a representative should visit the local Code Enforcement Office, and ask for a "Permit Search" on the property address.

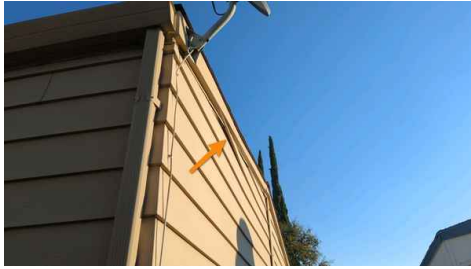
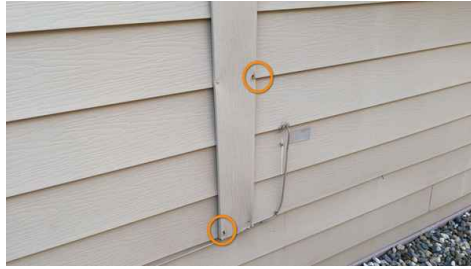
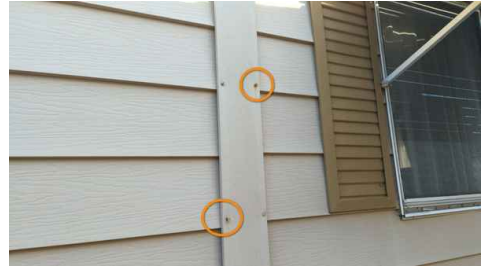
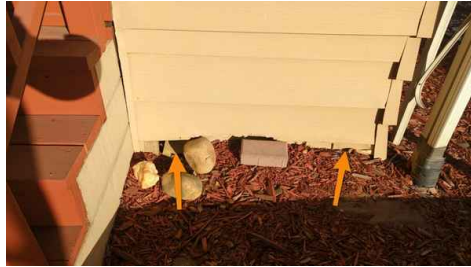
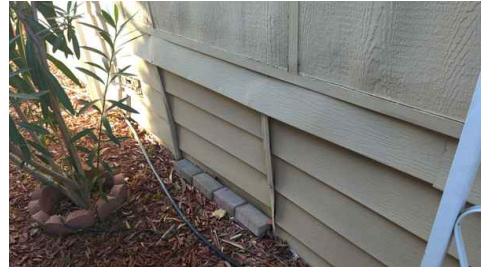
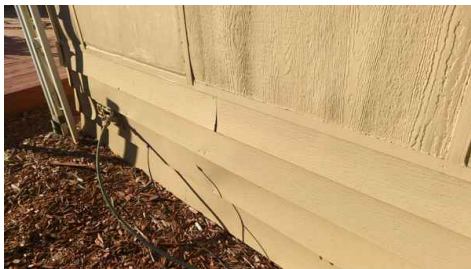
## REAR EXTERIOR AND SUN ROOM

One or more areas of siding were loose or warped. Recommend a qualified siding contractor repair or replace siding as needed.

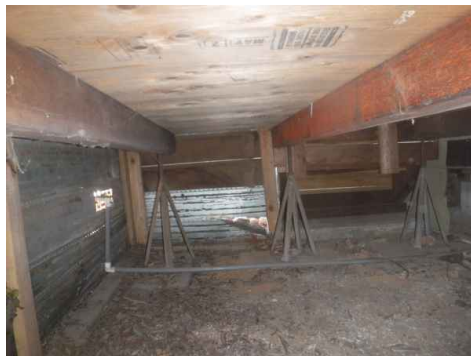
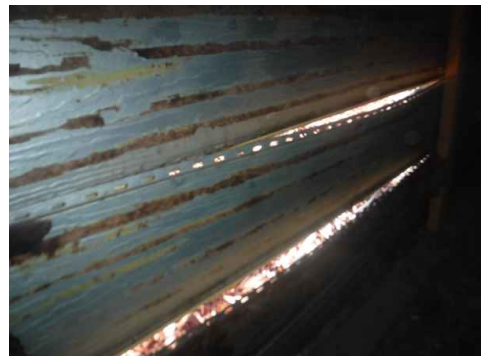
## 3.2.1 Wall Covering, Flashing &amp; Trim

**LOOSE/WARPED SIDING**

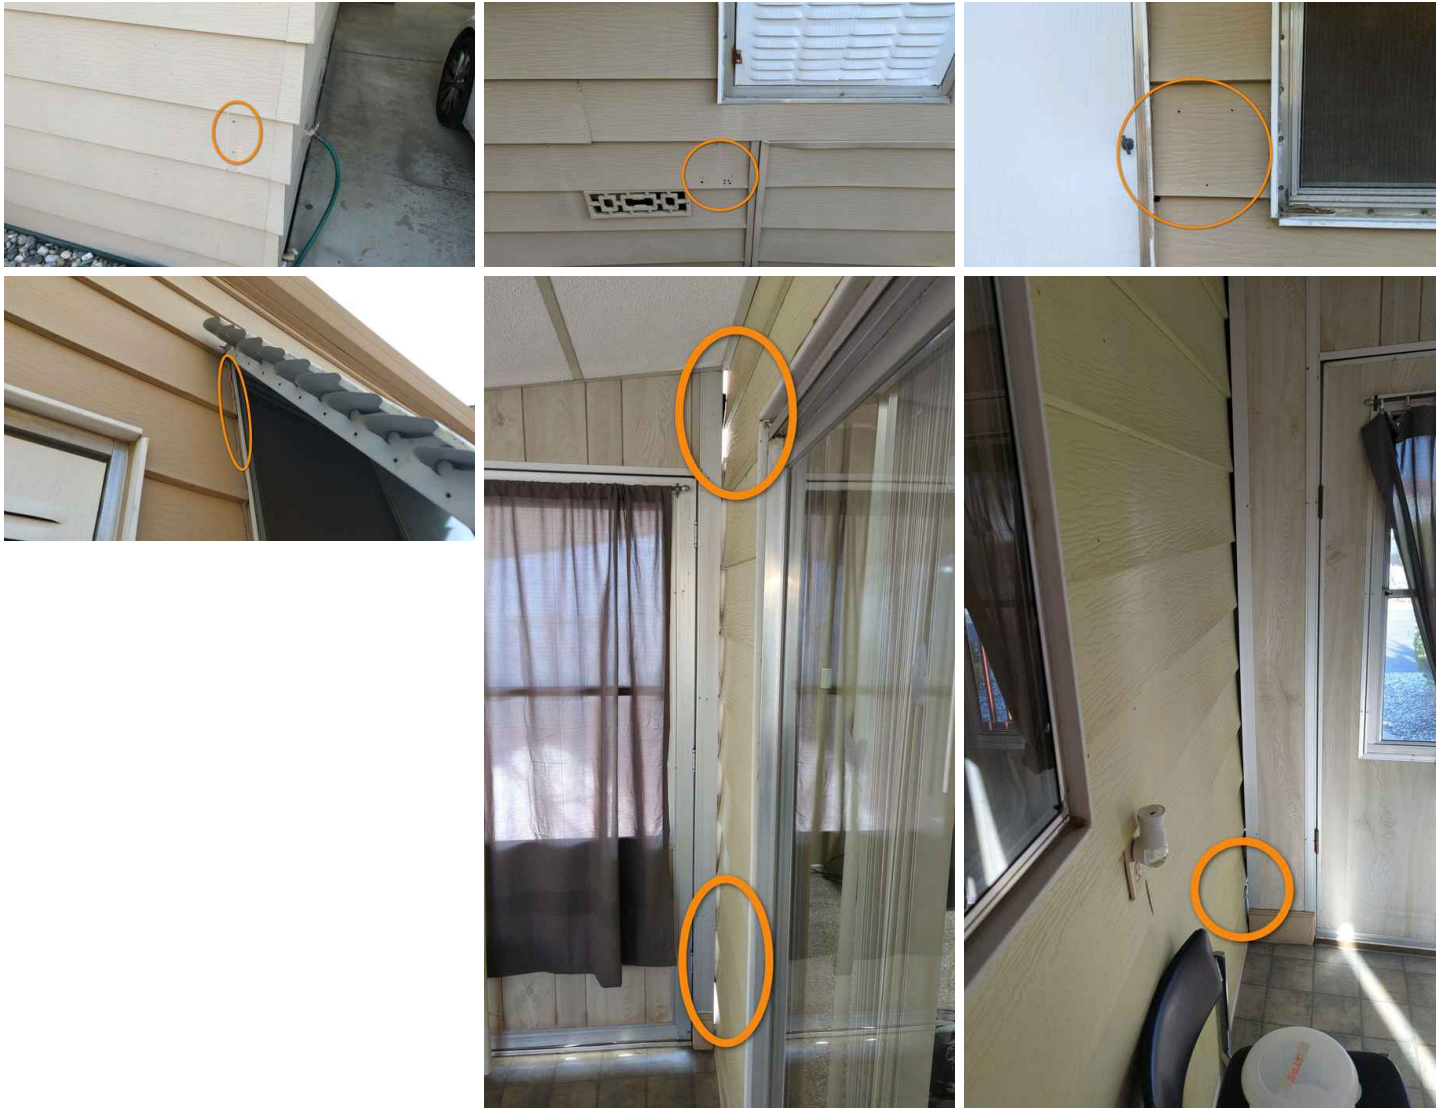
## 3.2.2 Wall Covering, Flashing &amp; Trim

**VOIDS**

Voids noted to siding in various areas. Recommend sealing with approved materials.

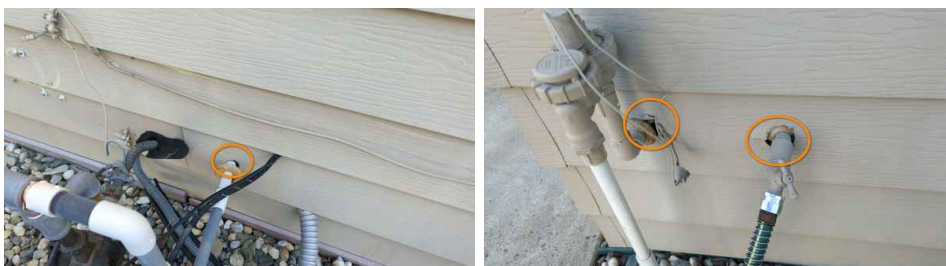
## 3.2.3 Wall Covering, Flashing &amp; Trim

**WALL PENETRATIONS SEALANT**

Recommend sealing various wall penetrations in order to prevent moisture/insect intrusion.

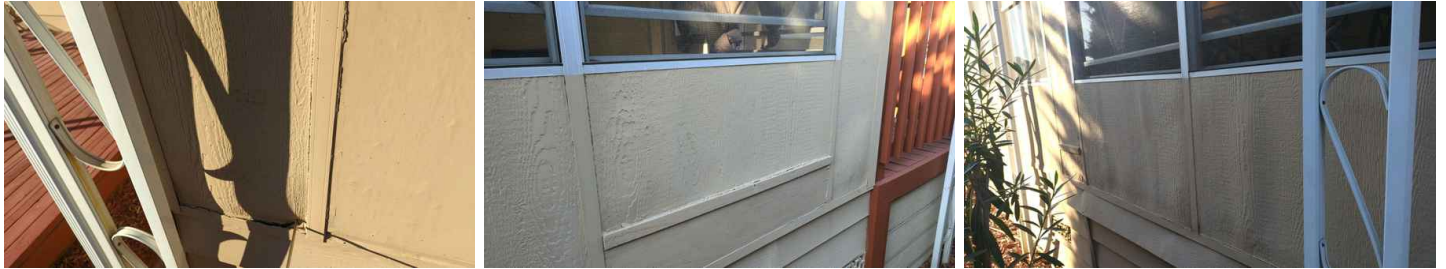
## 3.2.4 Wall Covering, Flashing &amp; Trim

**WOOD SIDING VERY WEATHERED**

Wood siding covering exterior walls of the home showed signs of moderate weathering and deterioration commensurate with the age of the home. Wall surface re-finishing/painting is recommended.

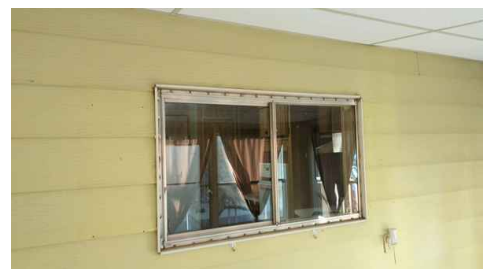
## 3.3.2 Exterior Windows

**MISSING SCREEN**

Some screens are missing. Replace as needed.

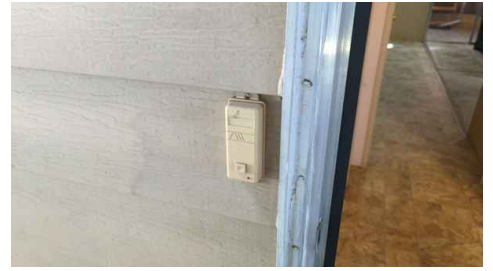
## 3.4.1 Exterior Doors

**DOORBELL DOESN'T FUNCTION**

Doorbell does not function. Make repairs as needed.

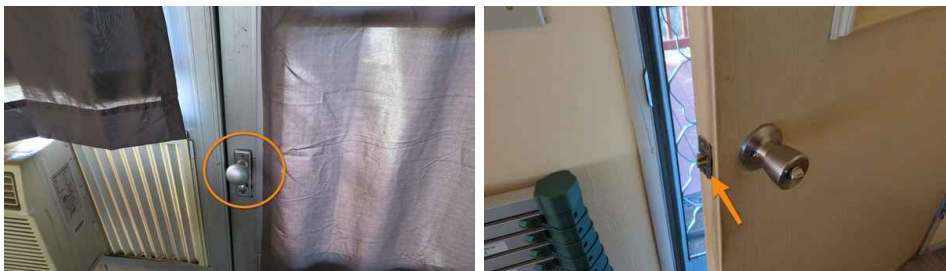
## 3.4.2 Exterior Doors

**LOOSE HARDWARE**

Loose hardware observed on exterior door. Improved fastening needed.

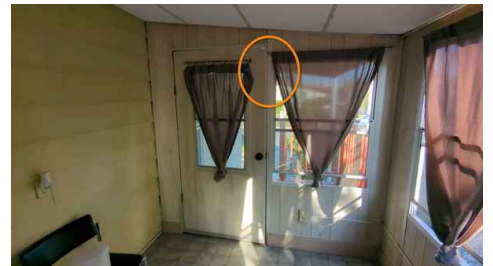
## SUN ROOM

Door rubs on the jamb and needs adjustment for it to function appropriately.

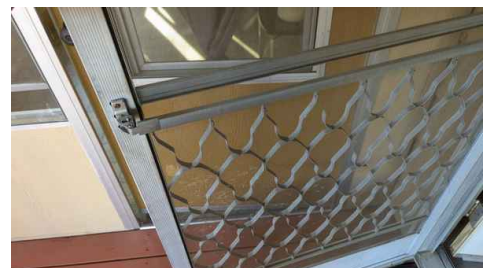
## 3.4.4 Exterior Doors

**SCREEN DAMAGE**

## FRONT DOOR

The screen door material is damaged and needs repair or replacement.

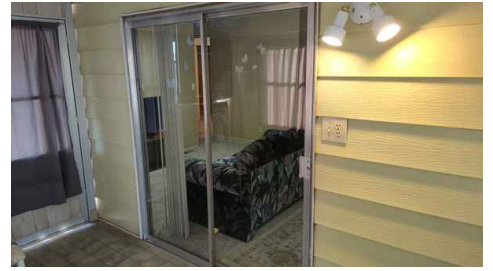
Screen doors are missing in some areas. Install as needed.

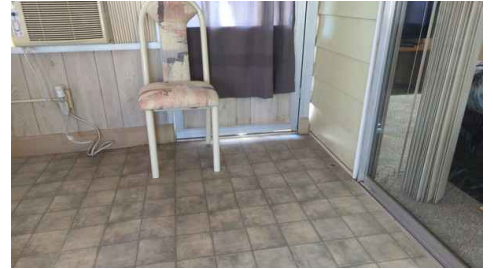
## 3.4.6 Exterior Doors

**WEATHER SEAL INSUFFICIENT**

Gaps noted around the door. This can result in significant energy loss and moisture intrusion. Recommend installation or improvement of weather-stripping and/or door adjustments as needed.

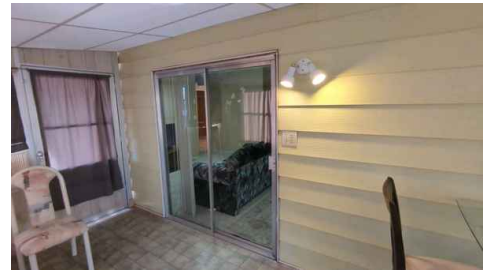
## 3.4.7 Exterior Doors

**SINGLE PANE - TEMPERED GLASS**

One or more glass doors at the residence are single pane and would benefit from replacement/upgrading with dual pane units for improved heating/cooling efficiency. The glass present is tempered safety glass.

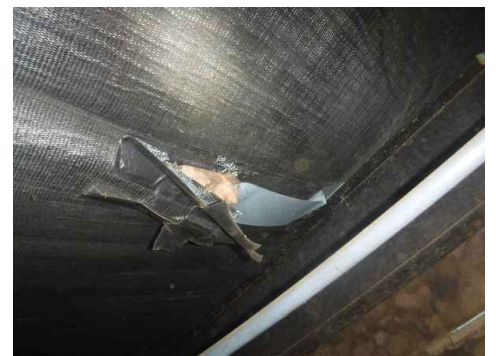
### INSULATION PREVENTS FULL VIEWING

Under floor insulation restricts full viewing.

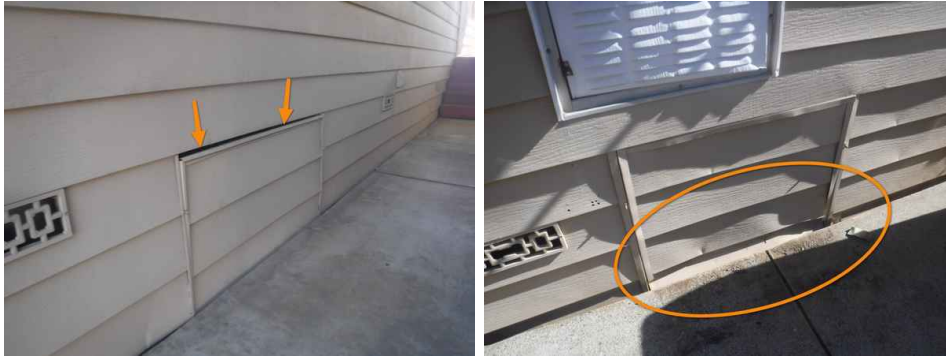
The crawlspace access hatches would benefit from repairs. One is very difficult to close fully and has damage. The other has a gap at the top which may allow for pest/rodent entry.

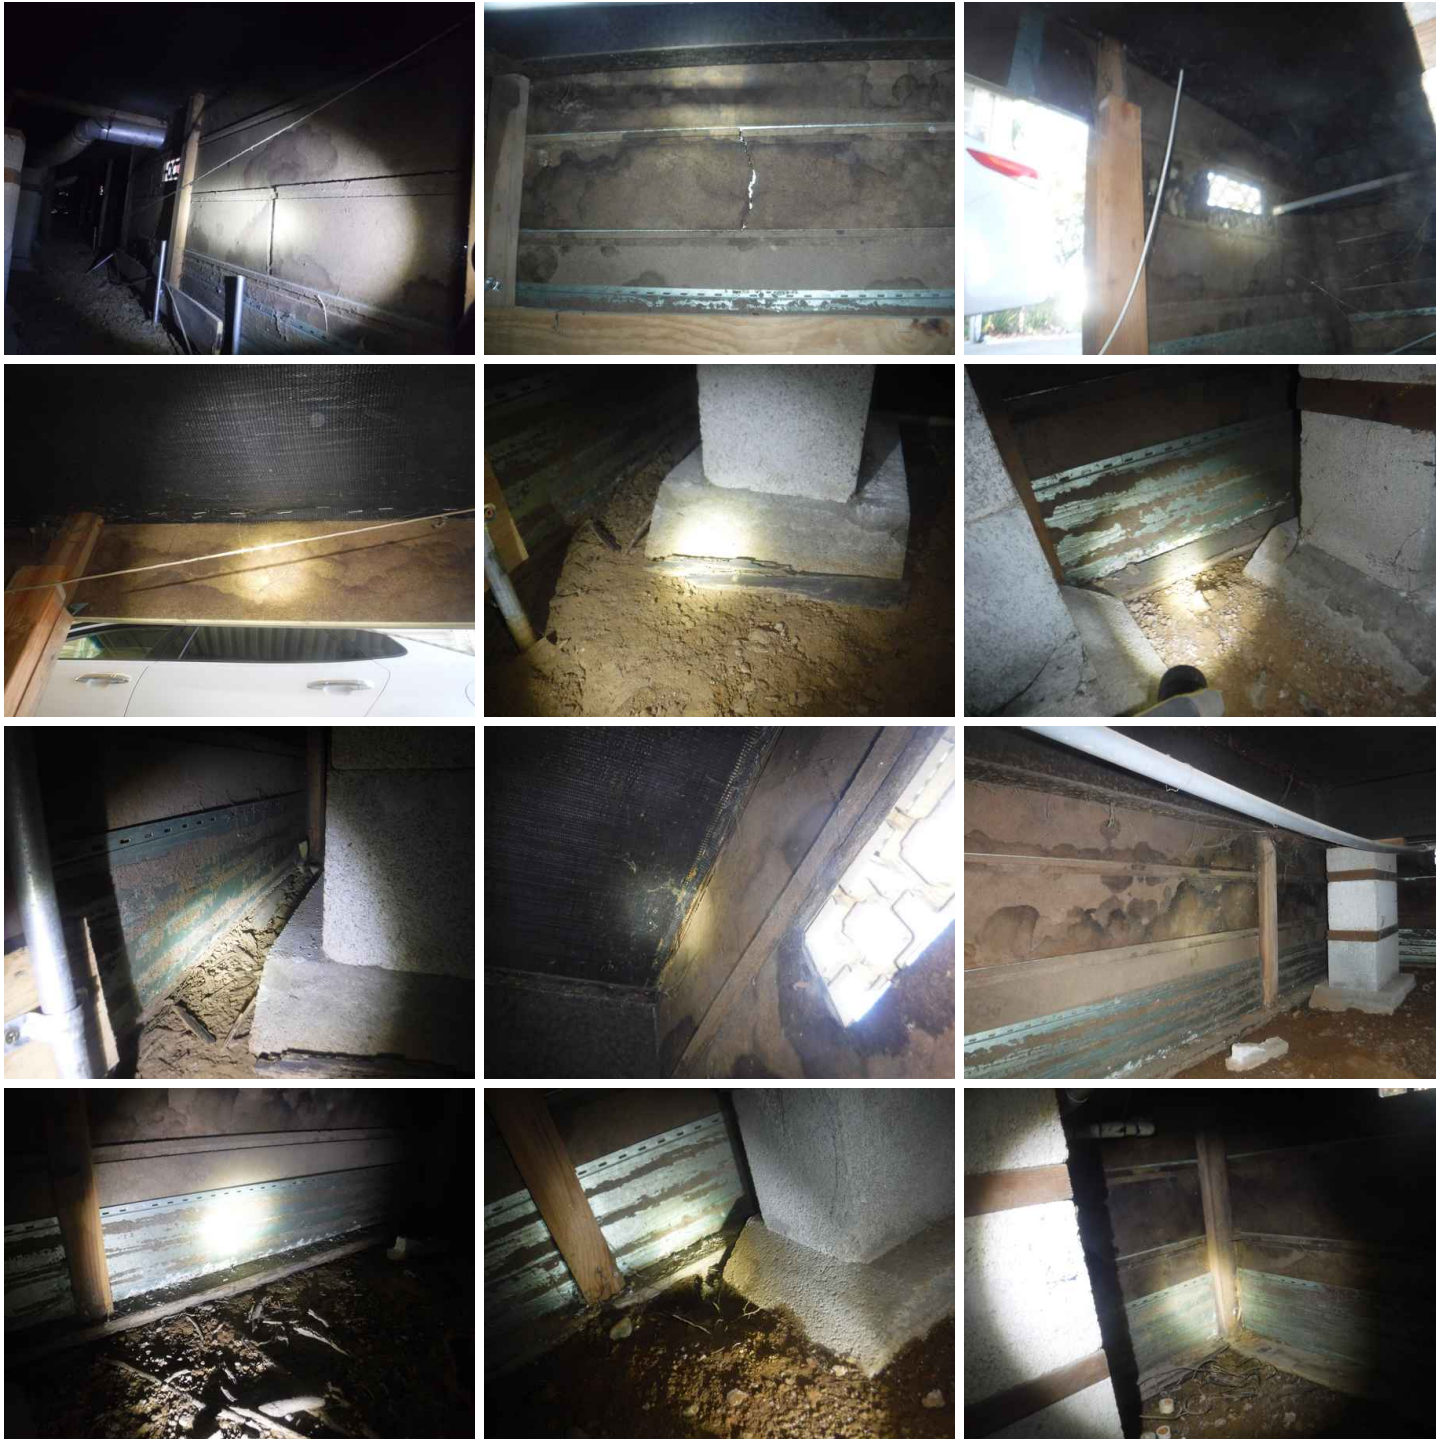
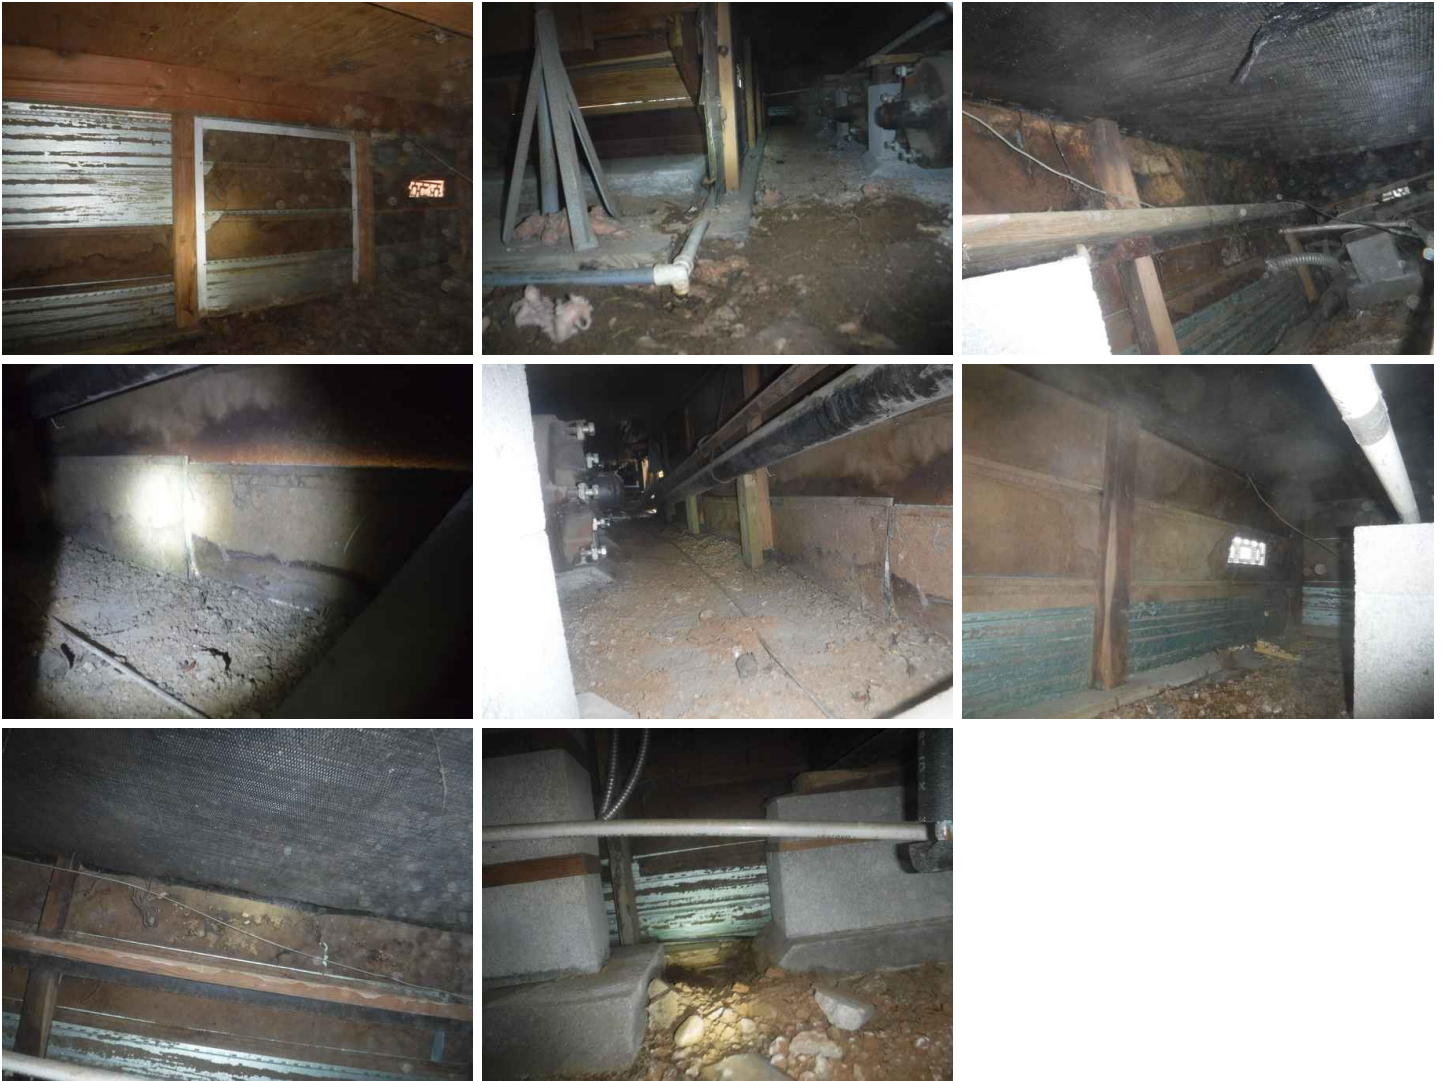
## 5.3.1 Walls

**APRON STAINING AND DETERIORATION**

**Evaluation/Repair Needed and/or Safety**

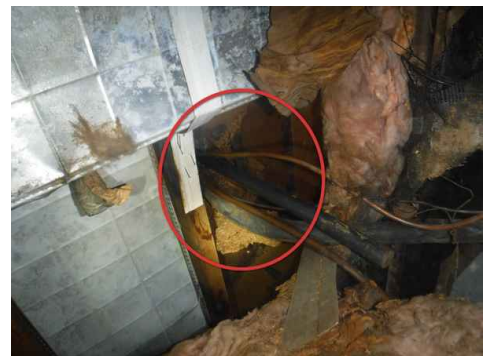
## 5.5.1 Beams &amp; Underfloor

Moisture damage/deterioration noted to subfloor and/or surrounding wood members. A licensed framing contractor should be called to make further evaluation and repairs as needed. A WDO (Wood Destroying Organism) inspection is recommended for further evaluation.

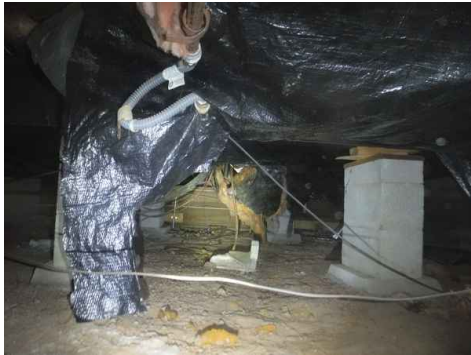
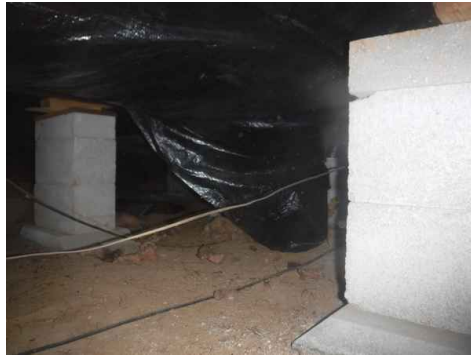
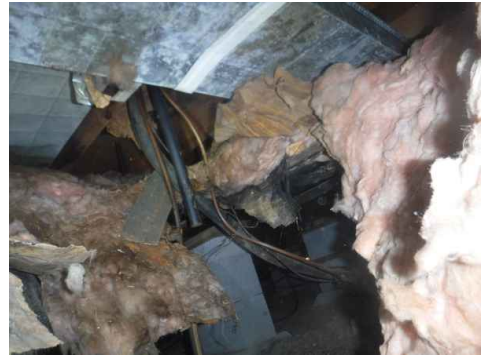
## 5.5.2 Beams &amp; Underfloor

**INSULATION LOOSE**

Under floor insulation is loose in some areas and needs re-securing and/or replacement.

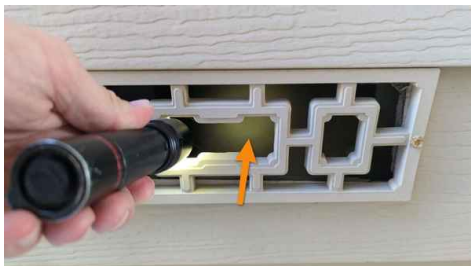
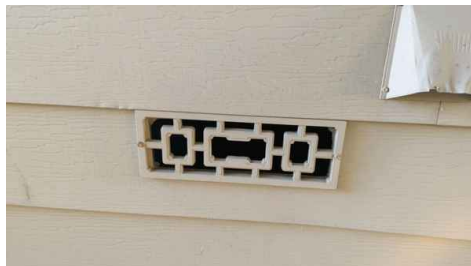
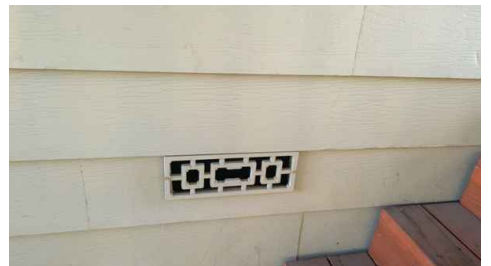
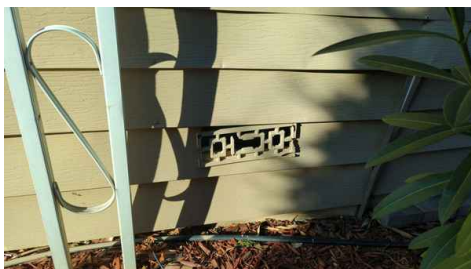
THROUGHOUT (MORE THAN PICTURED)

All crawlspace vent screens are missing and need replacement to prevent animal intrusion.

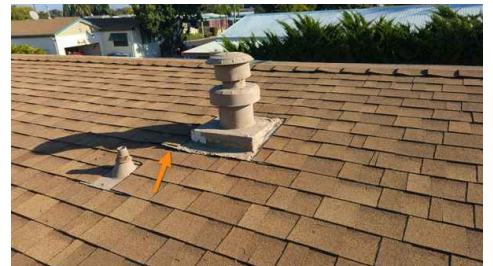
**FLASHING LIFTED**

Flashing is lifted in some areas and need to be nailed or glued down.

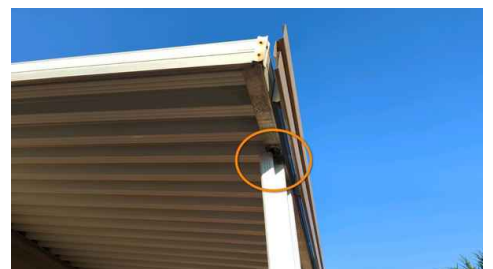
## 6.4.1 Gutters &amp; Downspouts

**DOWNSPOUTS DISCONNECTED**

## LEFT SIDE EXTERIOR

Downspouts are disconnected in some areas. Re-securing is needed to improve site drainage.

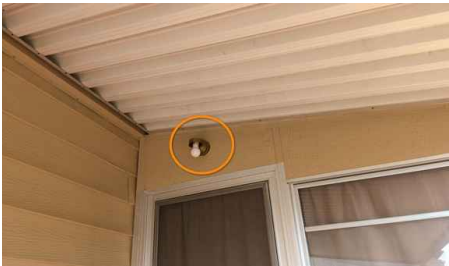
**Lights & Switches (Exterior):** Lights may not be operational  
Sun room

Lights may not be operational in some areas, possibly due to bad bulbs, ballasts or switches. Replace defective bulbs and test fixtures for proper operation and make repairs if needed.

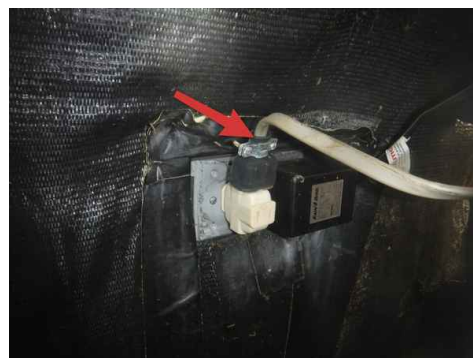
Improper jumper observed in the crawlspace. Romex wiring is installed with a plug end spliced onto it providing power to an unknown location. Unprofessional electrical work that needs to be corrected by a licensed electrician. It should be unplugged until permanent wiring can be installed. Electric shock/fire hazard.

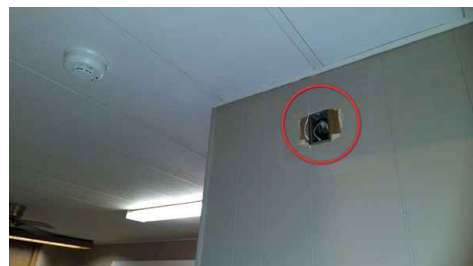
HALL

Open junction box noted. Unsafe conditions exist. A cover plate is recommended. All work around electricity should be done by a qualified contractor.

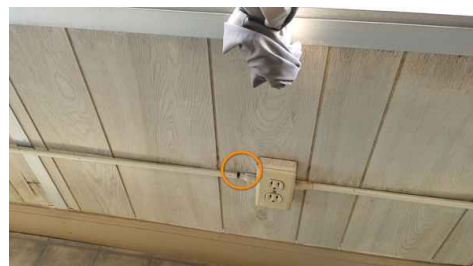
## 8.4.3 Branch Wiring Circuits, Breakers &amp; Fuses

**LOOSE CONDUIT**

SUN ROOM

Loose conduit observed in need of improved fastening.

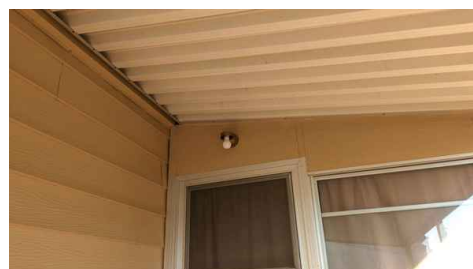
## 8.5.1 Lights &amp; Switches (Exterior)

**FIXTURE COVERS MISSING**

SUN ROOM

Light fixture covers are recommended at exterior fixtures.

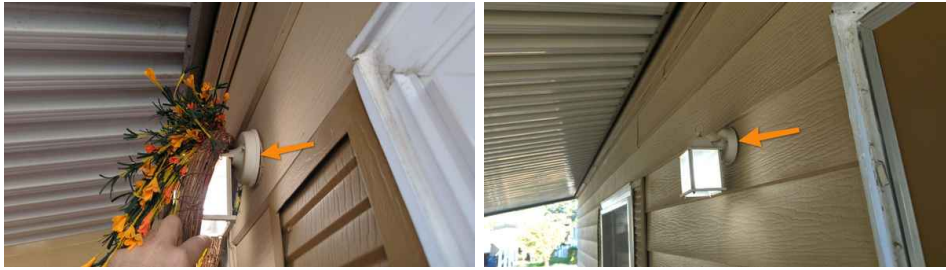
Some light fixtures and/or covers are loose and should be secured.

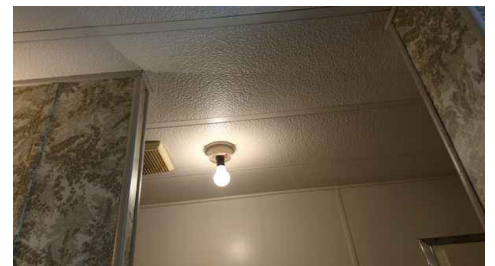
**FIXTURE COVERS MISSING**

## PRIMARY BATHROOM

Light fixture covers are recommended at various fixtures.

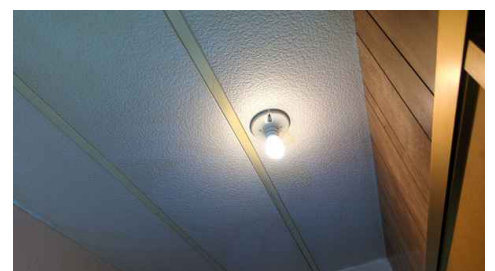
One or more light fixtures were observed to be improper for closet lighting. Light fixtures without a cover/globe may overheat stored items such as paper or cardboard and pose a fire hazard. Although this may have been acceptable at the time of construction, we recommend replacing the light fixture(s) as a safety upgrade.

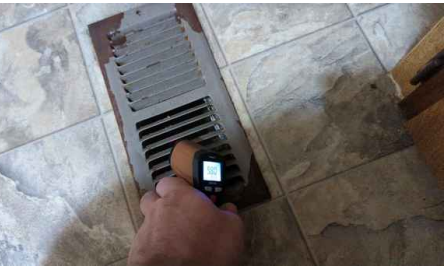
**Operation & Cabinet: Operational Gas Furnace**

The typical service life for a forced air gas furnace is 20-25 years. General condition appears serviceable. Unit operated normally at the time of the inspection and produced an adequate heating temperature, unless mentioned below. Suggest periodically cleaning/servicing blower motor, pilot light, vent system and burners. Annual servicing recommended.

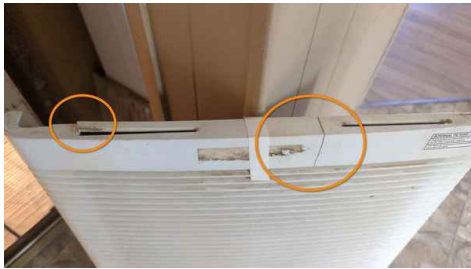
**COVER DEFECTS**

Defects with the furnace cabinet cover were observed. Repair/replace as needed.

Damage

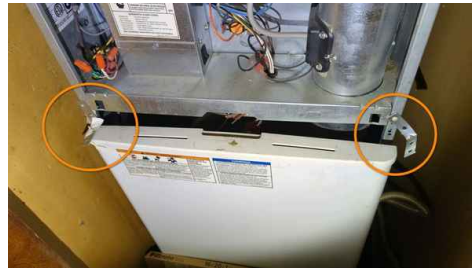
Brackets added because cover doesn't stay in place well

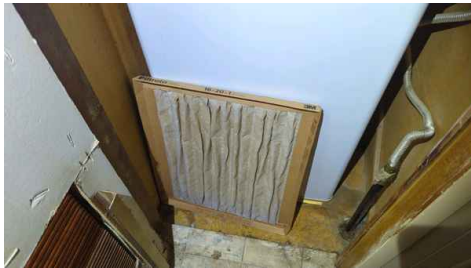
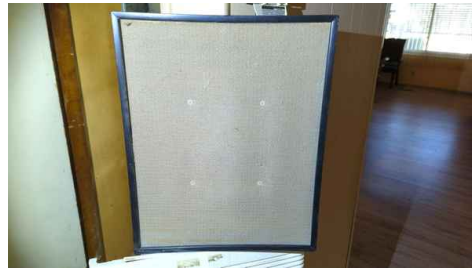
**FILTER DIRTY**

The filter is in need of cleaning or replacement. Replacing or cleaning filters every 30 to 45 days is recommended.

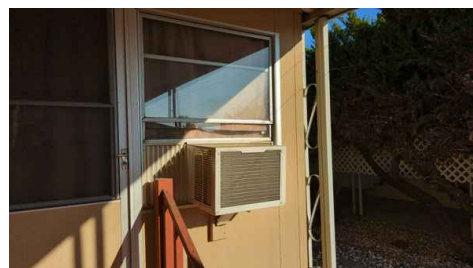
### WALL MOUNTED AIR CONDITIONER

Wall mounted air conditioners are beyond the scope of a standard home inspection. Inquire with the seller regarding condition. Any mention of its condition will be done so at the inspectors discretion.

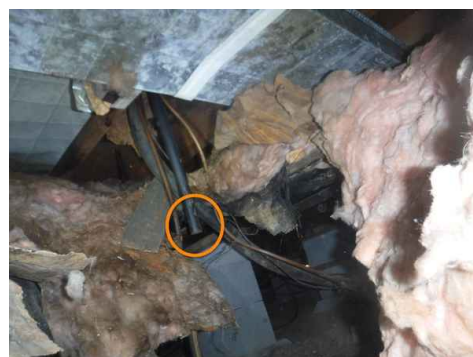
Condensate line terminates into the crawlspace. We recommend that this line be extended to an exterior location.

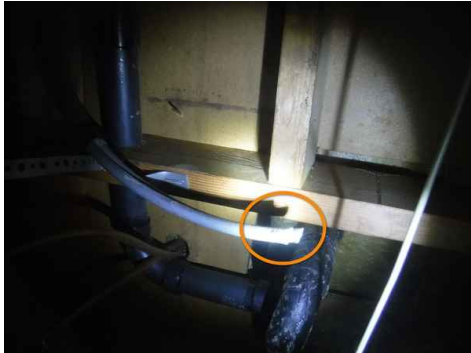
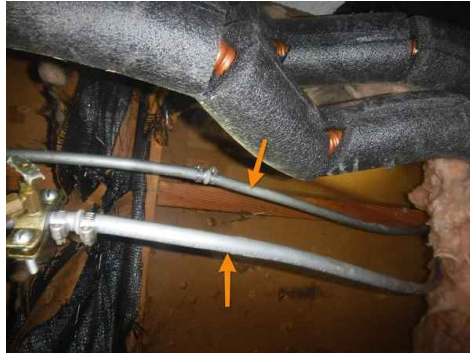
Disconnected

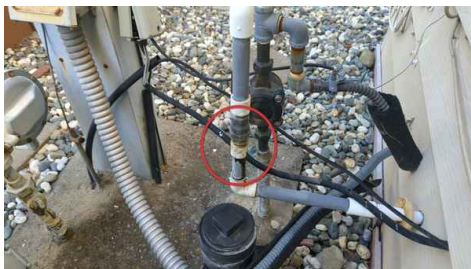
**SUPPLY PIPE LEAKING**

Leakage noted at a supply pipe. Recommend a qualified plumber evaluate and repair.

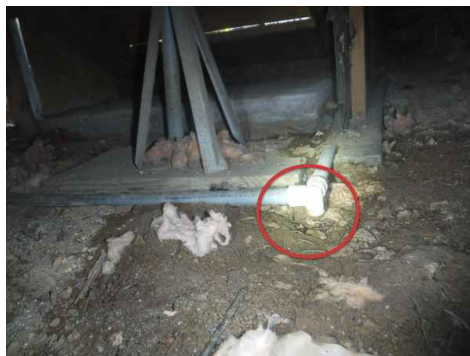
## 11.3.2 Water Supply Lines

Evaluation/Repair Needed and/or Safety

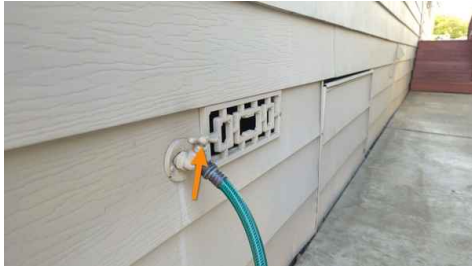
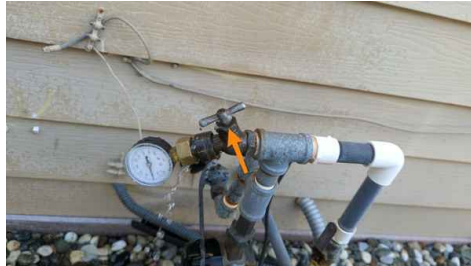
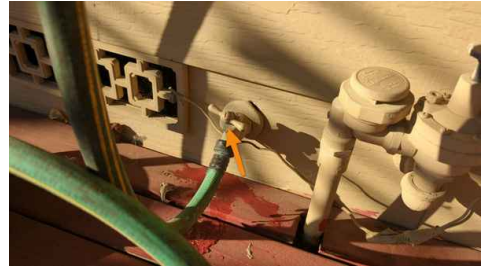
**LEAKING BIBB**

Hose bibbs at some locations of the house leak at the stem when operated. Recommend repair or replacement.

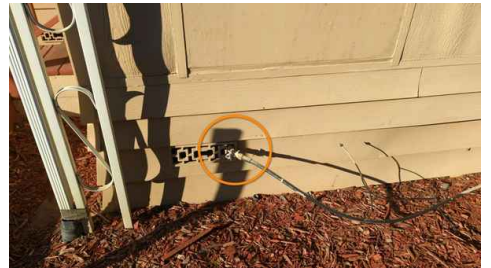
LEFT SIDE EXTERIOR

**NOT OPERATIONAL**

Hose bibb was not operational at the time of the inspection. Make further evaluations and repairs if needed.

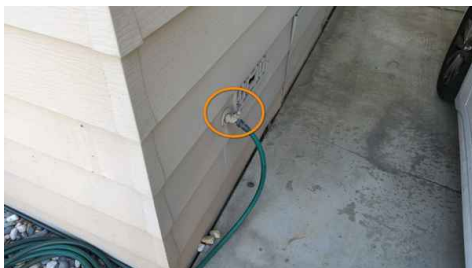
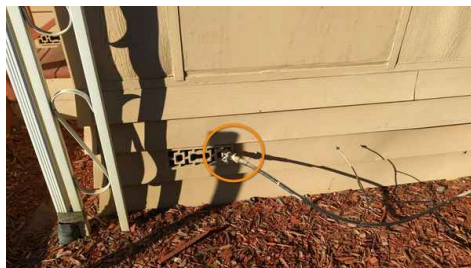
**LOOSE BIB**

Loose hose bibbs observed in need of corrective service/improved fastening.

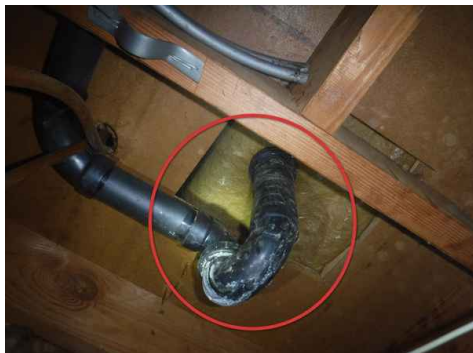
Leakage noted at a drain, waste or vent pipe. Recommend a qualified plumber evaluate and repair. Please be aware that the source of the leak under the primary bathroom shower was not fully visible and may not be a drain pipe.

Leak under hall bathtub

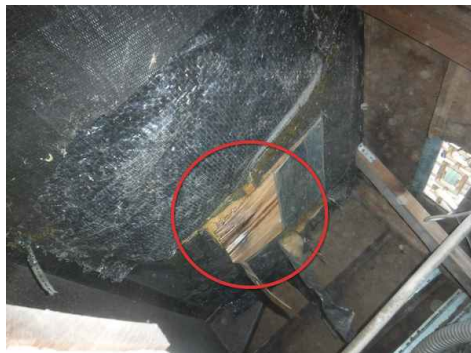
Water dripping down under primary bathroom shower

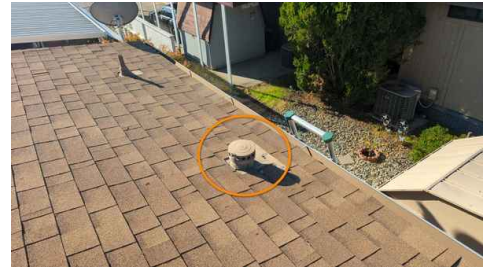
The water heater flue may not extend far enough above the roof for proper drafting per current standards. Evaluation recommended by a licensed plumber.

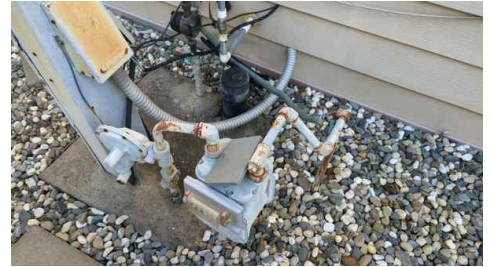
**CORROSION**

Gas pipes were corroded. This can lead to gas leaks. Recommend contacting local utility company for evaluation and repair.

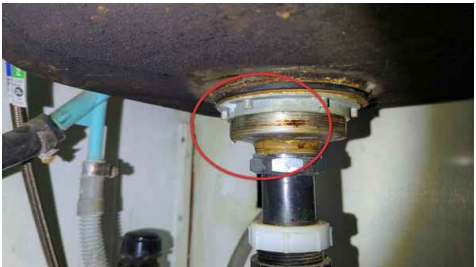
**DRAIN LEAKING**

Leakage noted at sink drainage piping. A licensed plumber should be called to make repairs as needed.

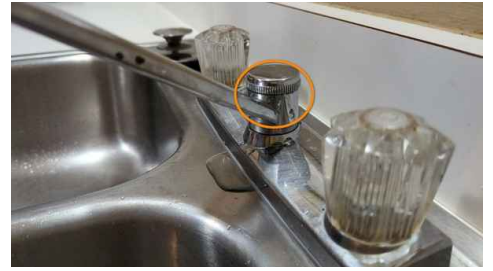
The kitchen faucet leaked at the handle when the water was turned on. The cartridge valve should be replaced.

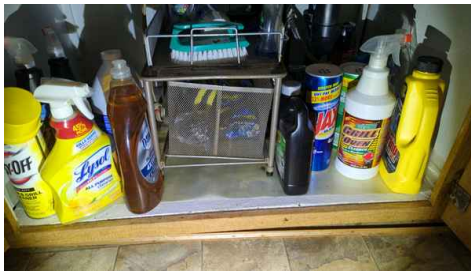
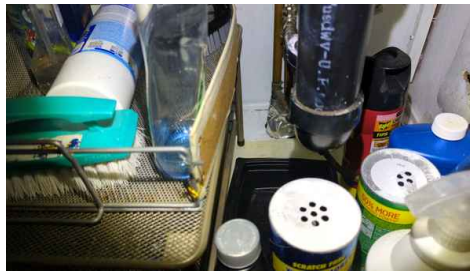
**STAINING/MOISTURE DAMAGE**

Staining/moisture damage was noted below the sink. The false bottom is warped. Make further evaluations and repairs as needed.

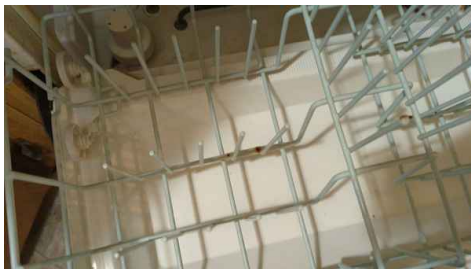
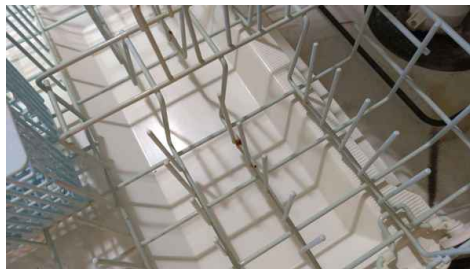
**RUST DISH RACKS**

Rusting is noted to the dish racks. Repair as needed.

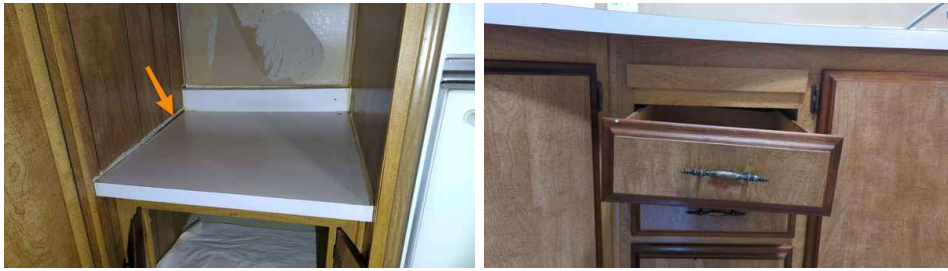
**SUNKEN COUNTER**

The small section of counter is sunken down and needs improved fastening/support.

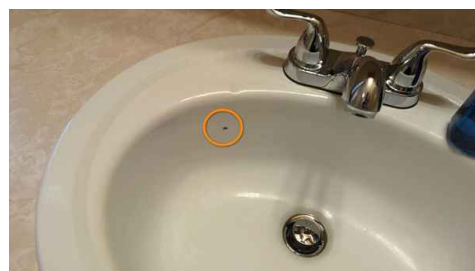
HALL BATHROOM

### **SURFACE DEFECTS**

Surface defect(s) observed at the sink that would benefit from corrections to prevent possible worsening conditions. Regular maintenance item.

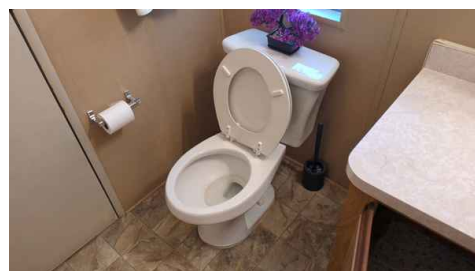
13.3.1 Toilet

### **TOILET LOOSE**

HALL BATHROOM

The toilet was loose at the floor and needs securing. We recommend resetting the toilet with a new wax seal and evaluating the surrounding area for damage.

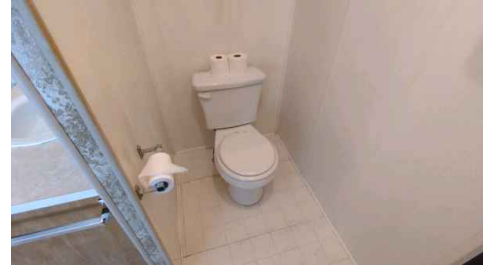
The toilet rocks and needs leveling. We recommend leveling the toilet with a new wax seal and evaluating the surrounding area for damage.

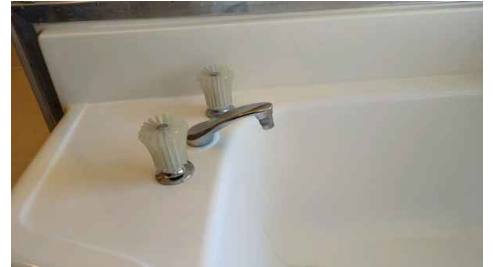
## PRIMARY BATHROOM

**Evaluation/Repair Needed and/or Safety****CONSTANT DRIPPING**

Constant dripping was noted at tub faucet. Valve may need to be reset or replaced to correct this condition.

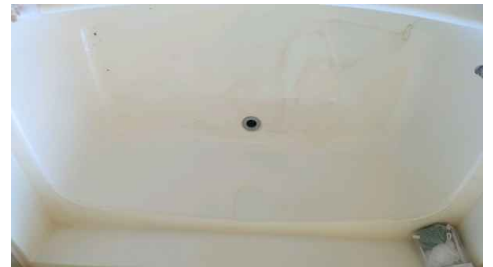
## 13.4.2 Tub/Shower Fixtures

**DRAIN PLUG MISSING**

The tub drain plug is missing and needs replacement.

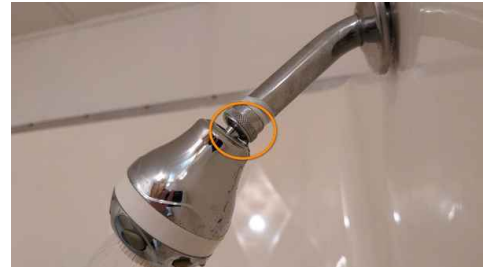
## 13.4.4 Tub/Shower Fixtures

**SHOWERHEAD LEAKING**

Leakage noted at the showerhead. Repair or replace as needed.

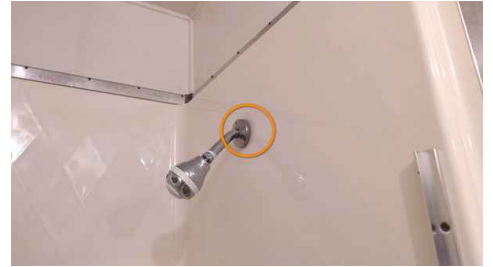
PRIMARY BATHROOM

**SHOWERHEAD PIPE LOOSE**

Showerhead pipe is loose and needs re-securing.

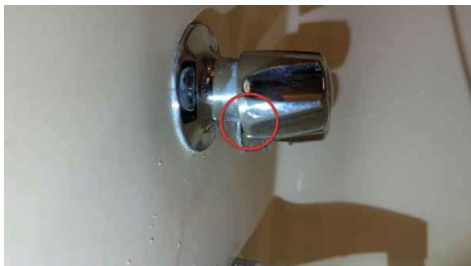
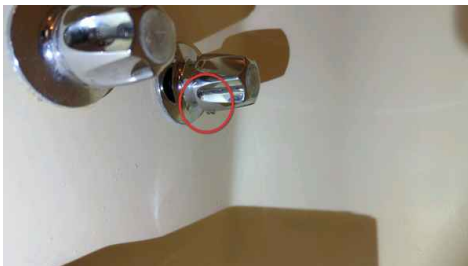
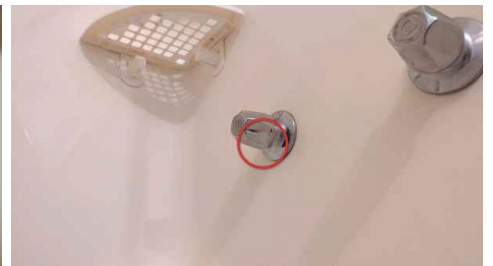
## 13.4.6 Tub/Shower Fixtures

**TUB/SHOWER VALVE LEAKING**

Leakage was noted at one or more shower/tub valve(s). Valve stem or cartridge appears to need replacement.

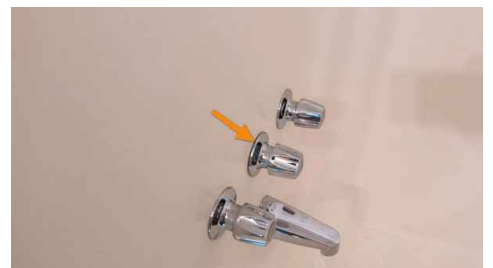
## 13.4.7 Tub/Shower Fixtures

**VALVE ESCUTCHEON SEALANT**

Valve escutcheon plate needs sealant applied.

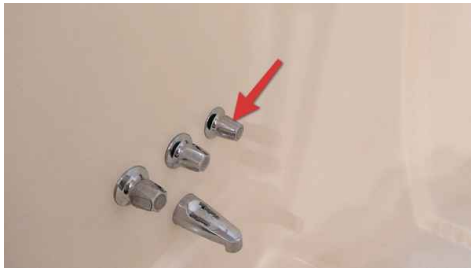
## 13.4.8 Tub/Shower Fixtures

**INOPERABLE COLD VALVE**

The cold water valve was inoperable at the time of inspection. Opening the valve, water failed to discharge from the fixture. Review and repairs needed by a licensed plumber.

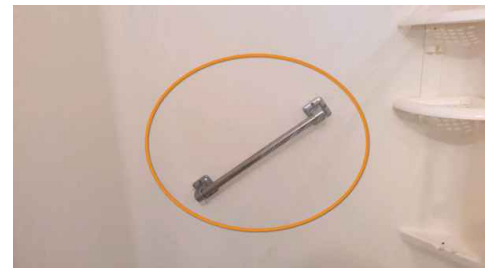
The grab bar is not well secured to the wall framing. It appears to be secured to the shower surround only and is loose.

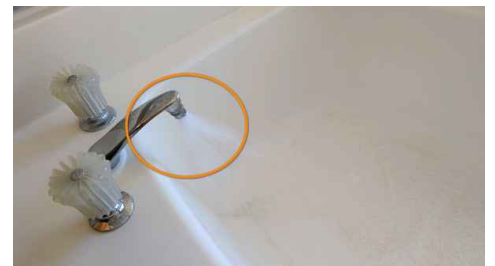
## PRIMARY BATHROOM

**AERATOR DEFECT**

Noted one or more obstructed or missing aerators making the flow of water less than optimal. Cleaning or replacement of the aerator is recommended per a regular maintenance plan.

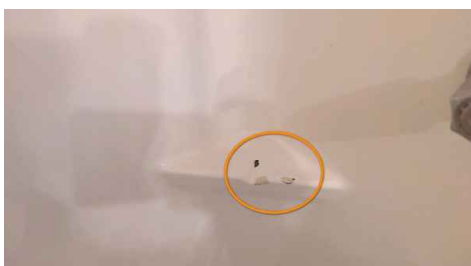
## 13.5.1 Tub/Shower Walls

**DAMAGE**

Surface defect(s) observed at the tub and/or shower that would benefit from corrections to prevent possible worsening conditions. In some instances, surface defects can continue to get worse and may lead to rusting and leakage. Regular maintenance item.

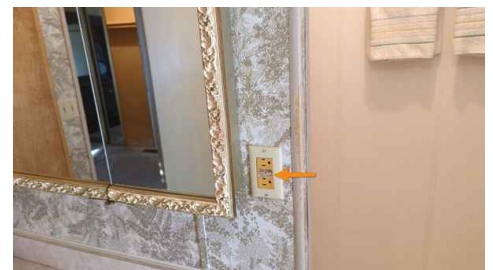
One or more GFCI (Ground Fault Circuit Interrupter) outlets were observed that are past the typical service lifespan and would benefit from a replacement, despite testing as functional, for improved health/safety conditions.
