## RESIDENTIAL INSPECTION

376 Spreading Oak Ln  
Rancho Cordova, CA 95670

11/03/2025

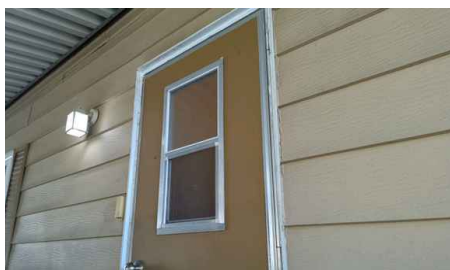
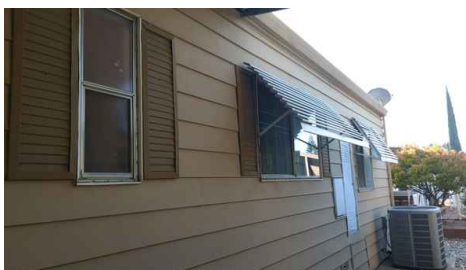
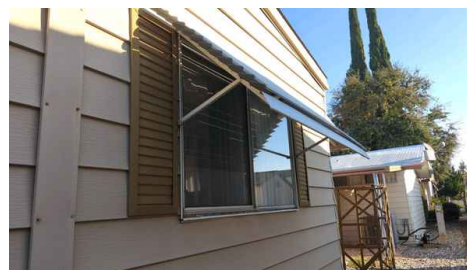
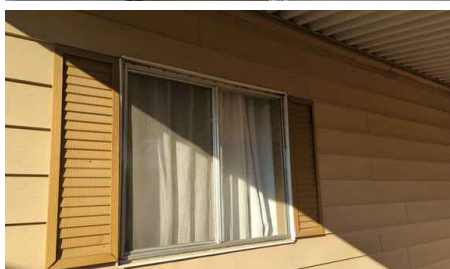
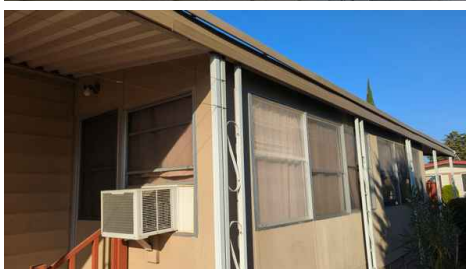
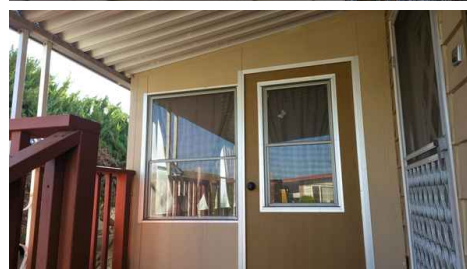
Various throughout

Single pane windows have a tendency to sweat or condensate during some conditions. Periodic cleaning may be needed around windows surfaces to prevent mildew buildup. These areas may need to be dried to prevent water damage from condensation.

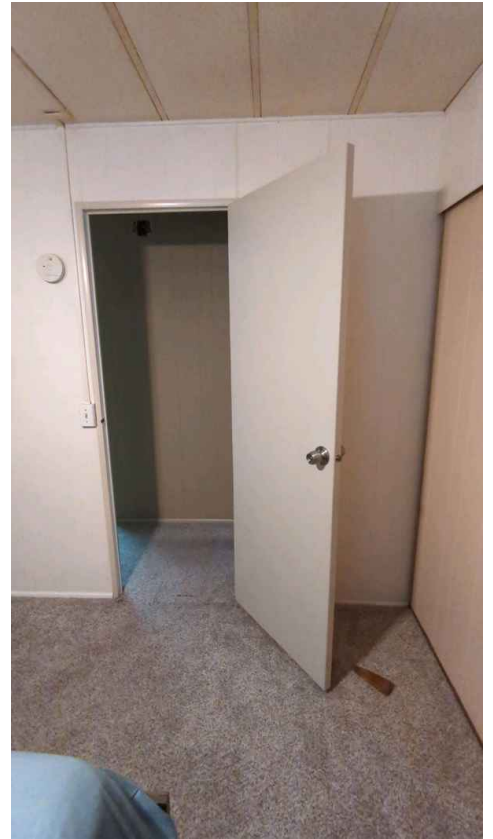
One or more doors fail to stay open and need adjustment or repair to function properly.

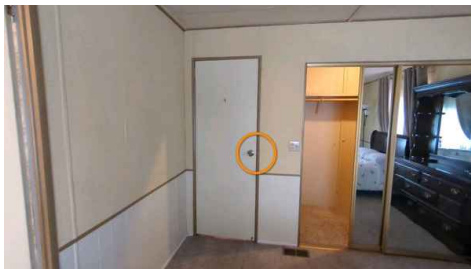
## PRIMARY BEDROOM

Doors in some areas of the house rub on the jamb and need adjustment to function appropriately. This may be causing the damage to the door which would also benefit from repairs.

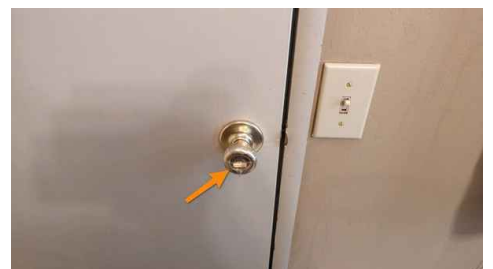
Door knob taped over. Repair/replace hardware as needed.

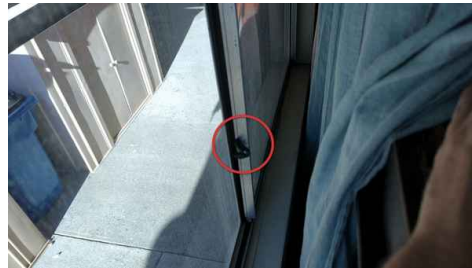
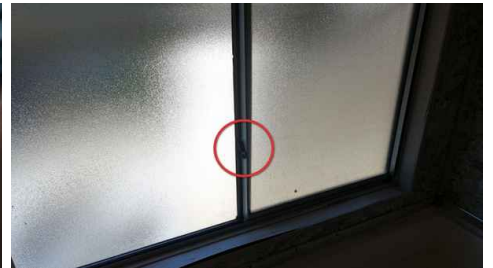
The window latch/lock does not function properly. Repair or replacement of the latch/lock is recommended for locking capabilities to ensure securing of the residence.

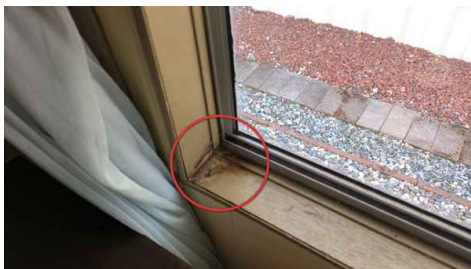
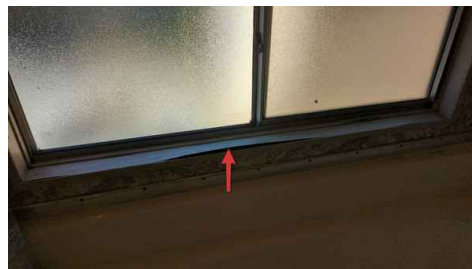
## 14.3.2 Windows

**MOISTURE DAMAGE**

Moisture damage noted around the window sill. Unable to determine if leakage is current. Monitor in the future and make repairs as needed.

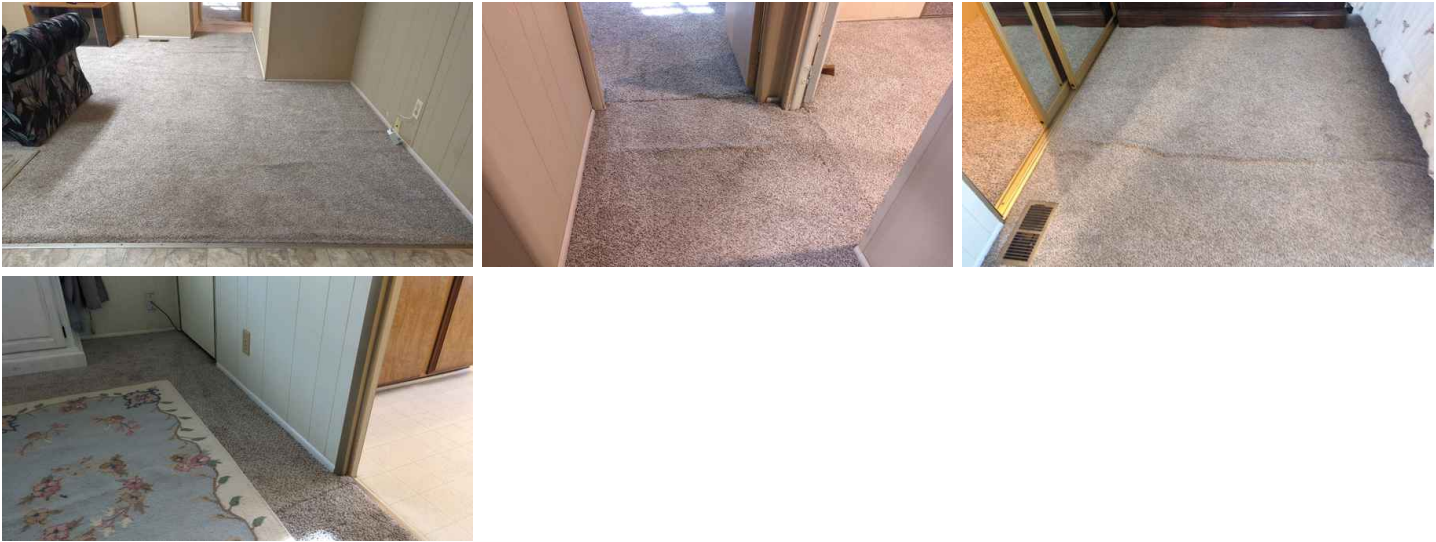
14.4.1 Floors

**CARPET LOOSE**

Carpet is loose in some areas. Re-stretch or repair carpet as needed.

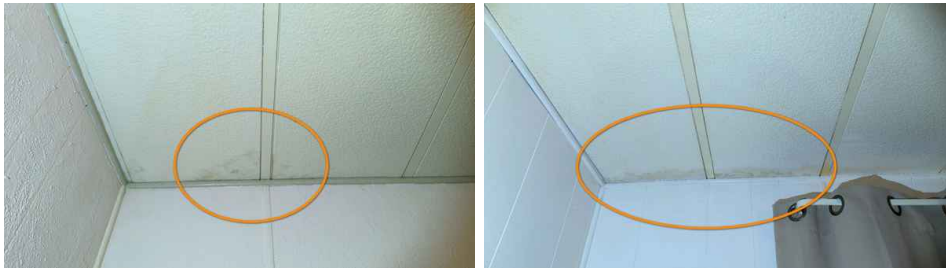
## 14.6.1 Ceilings

Moisture stains noted. Unable to determine if active leakage exists. Make inquiry with the seller as to the history of leaks. Make further evaluation and repairs if needed.

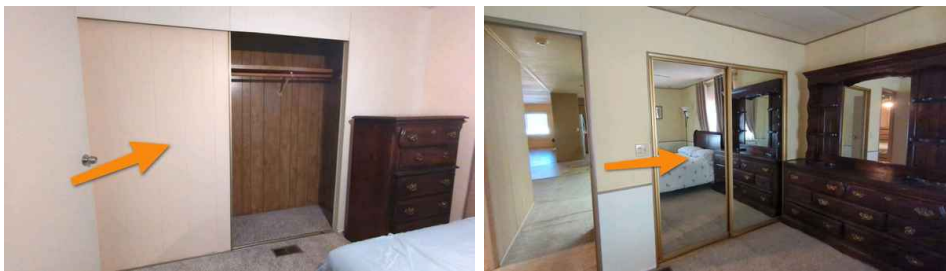
## 14.7.1 Closets

Closet door track is damaged making doors rough to operate. Repair as needed.

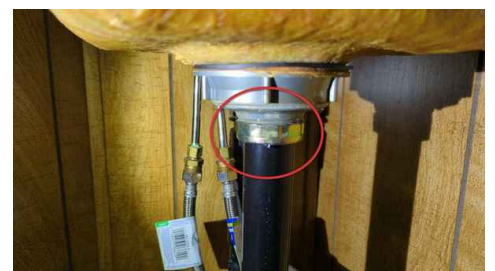
## 14.8.1 Wet Bar Sink &amp; Cabinetry

Leakage noted at sink drainage piping. A licensed plumber should be called to make repairs as needed.

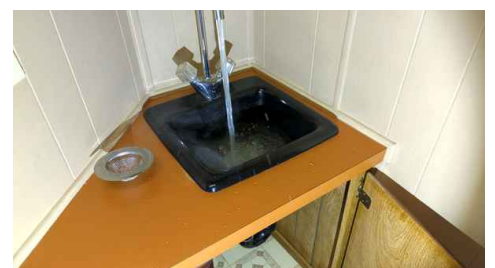
## 14.8.2 Wet Bar Sink &amp; Cabinetry

Noted one or more obstructed or missing aerators making the flow of water less than optimal. Cleaning or replacement of the aerator is recommended per a regular maintenance plan. Water splashes out of sink.

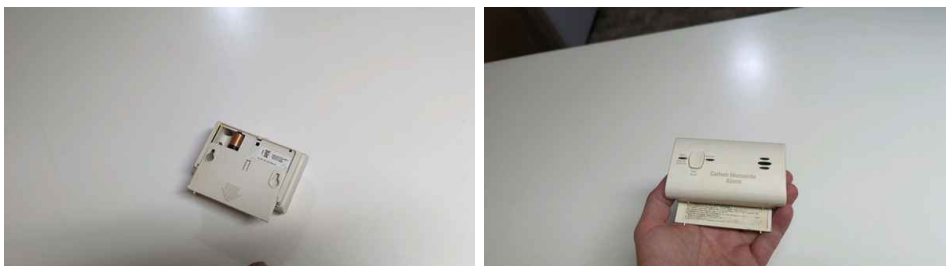
No carbon monoxide detectors are installed. One was present but needs new batteries. Repairs/replacement needed prior to occupancy.

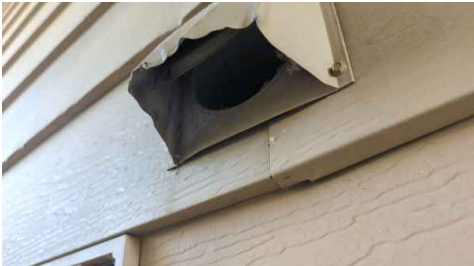
VENT CAP OPEN

Dryer hood vent is stuck open. Replacement with a louvered style vent cap is recommended to prevent animal intrusion.

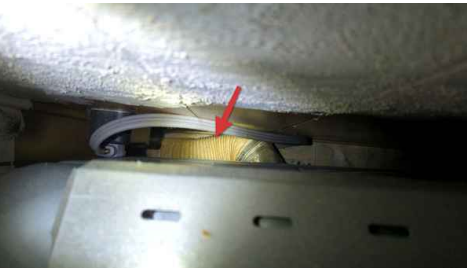
16.3.2 Dryer Components

DRYER VENT DEFECTS

The dryer vent is disconnected in the crawlspace which will allow for lint and hot, wet air to discharge under the residence. The duct is also not UL listed which is a potential fire hazard. Replacement with a smooth walled, rigid duct and/or flexible, semi-rigid duct is needed.

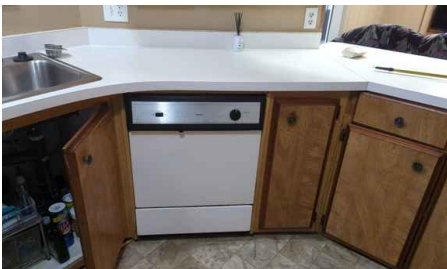
**Appliances: Dishwasher Off - No leaks**

The dishwasher was turned off before the inspection was completed. No leaks were noted on the floor below the unit at the time of completion.

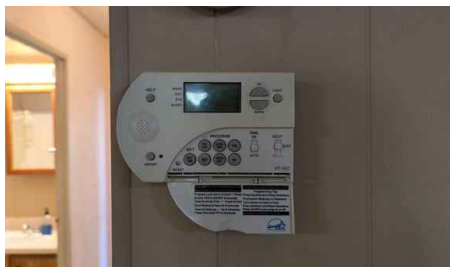
**Heating & Cooling: Thermostat Set To Original Temperature/Setting**

The thermostat was left at the original position/location before leaving the home.
